offprint: MONUMENTUM, december 1984

Koldinghus: the conversion of an old royal Danish castle

JOHANNES EXNER*

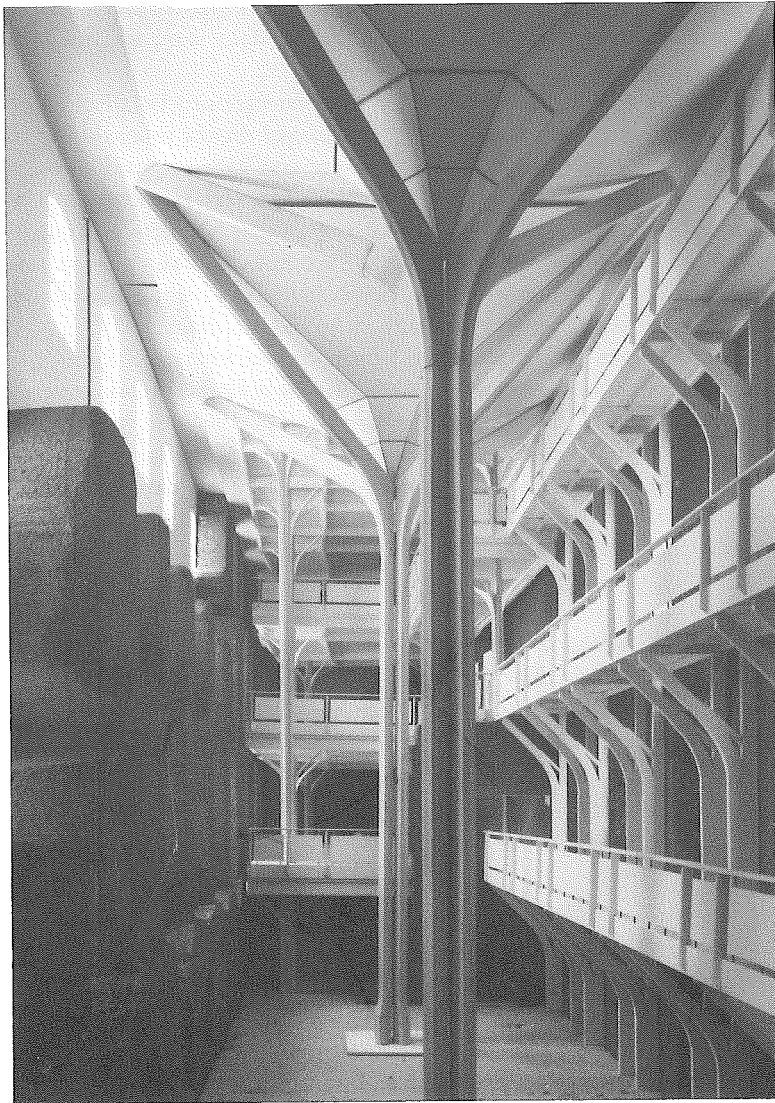
FIG. 1. A model photograph showing the ruined hall in the second proposal which was accepted and is now in progress. The load-bearing constructions are made of laminated timber. The closing of the aperture in the south wall (left) is a curtain-wall of timber, painted white internally and faced externally with oak shingles. (*Photograph: Ernst Kallesøe*)

In order to keep the ruins untouched and to preserve their 'narrative value', a framed structure has been designed to fit within the walls of the ruin (*Fig. 1*). Columns carry the floor decks and roof, and the design also

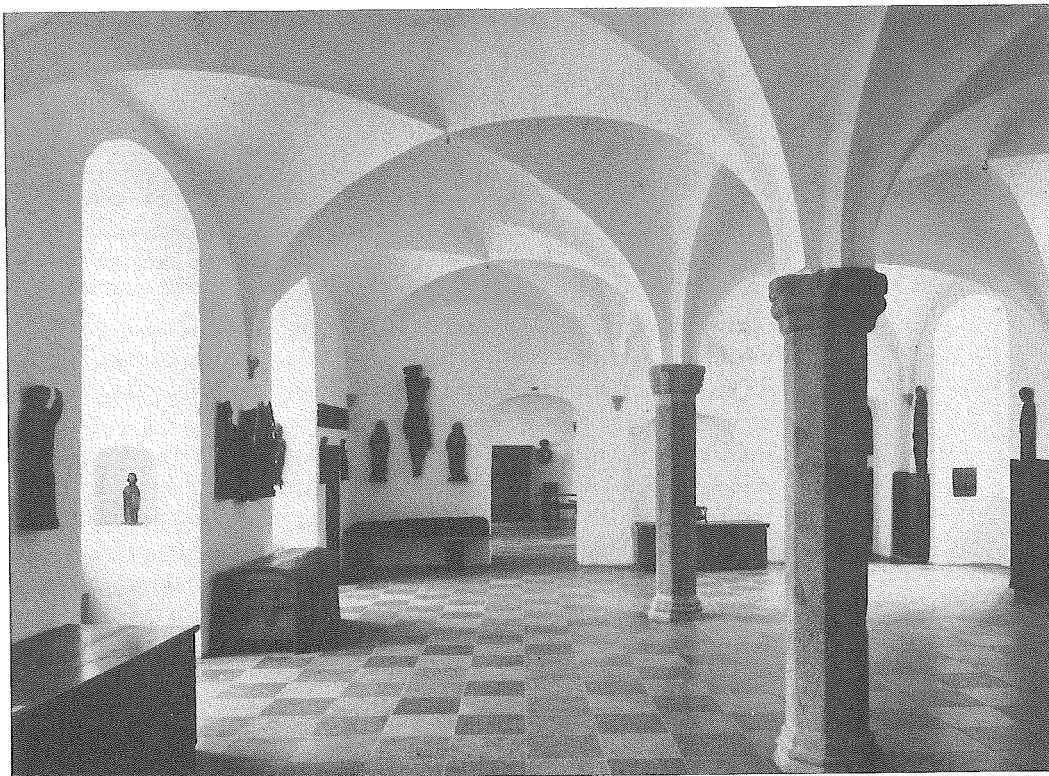
FIG. 2. An exhibition room in the north wing. The vaulted room was reconstructed in 1892 after the discovery of the octagonal granite columns in the town of Kolding. (*Photograph: Ernst Kallese*)

jointing of the fine Gothic masonry are well preserved, and the south gable can be observed by those with a keen eye in the later Christian III's chapel. There are fewer remains to be seen in the north wing, where several alterations and restorations have obliterated the early work (*Fig. 2*). No doubt more profound investigation would add to our knowledge of the Gothic house, but it will have to wait until time and money allow. The work being undertaken at present does not hinder future investigations.

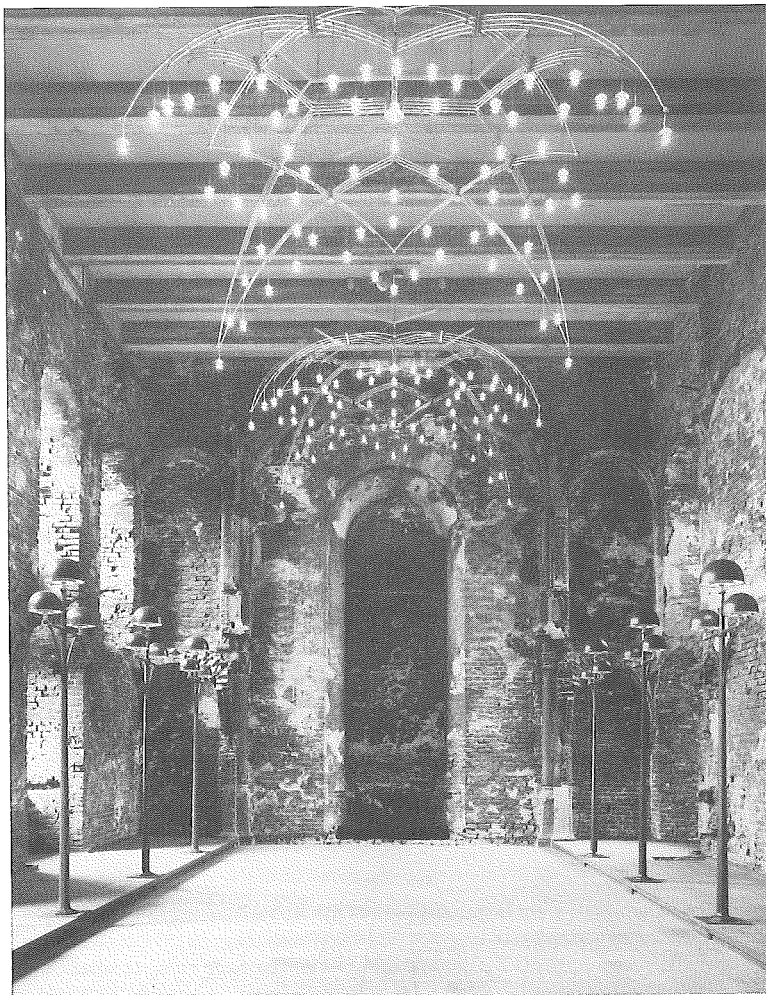
FIG. 4. Christian IV's church hall after restoration in 1980. The ruinous state of the room has been retained, but new floors have been laid and electricity and heating have been installed. The room is now used for concerts, lectures and exhibitions.

collapsed during the fire of 1808; it remained an open ruin until the 1930s when the tower was rebuilt by V. Norn who also constructed a ferro-concrete roof over the chapel. Several proposals for its reconstruction have been made, but even though important fragments have survived and we know about Christian IV's church building from other examples, there is insufficient reliable material on which to base a reconstruction. Our proposal was to leave the ruined structure intact, only adding what is necessary for its use, such as flooring, heating and lighting (*Fig. 4*).

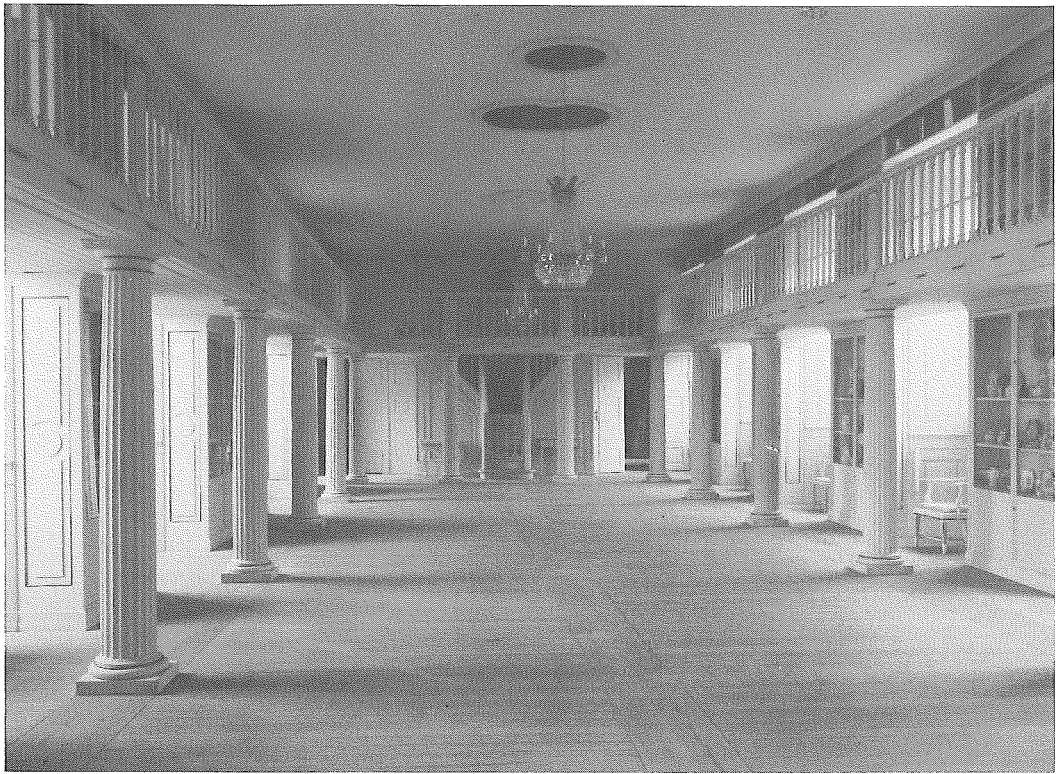
FIG. 5. The fixtures and furniture in the White Hall were originally part of the Royal Library in Copenhagen, designed by H.V. Koch in 1824. It has nothing to do with Koldinghus, but was placed there in 1914 as an exhibit. The fixtures are light and refined, and the room presents a dramatic contrast to the dark ruinous interior of Christian IV's church hall which is immediately next to it. (*Photograph: Ernst Kallesøe*)

As well as the chapel, the west wing contains on the first floor the White Hall, which was originally a part of the Royal Library in Copenhagen. It dates from the early nineteenth century, when it was designed by Jorgen Hansen Koch, and part of the interior was placed in Koldinghus during the restoration of the west wing in 1911–17 (*Fig. 5*). Although it has nothing to do with the castle, the interior is a fine example of the craftsmanship and design of its time, and the room's proximity to

the ruined chapel creates a piquant contrast of experiences. For that reason we thought it worthwhile to retain the library in its present setting, and in our opinion it also illustrates a now historical attitude towards preservation and restoration by a previous generation of architects.

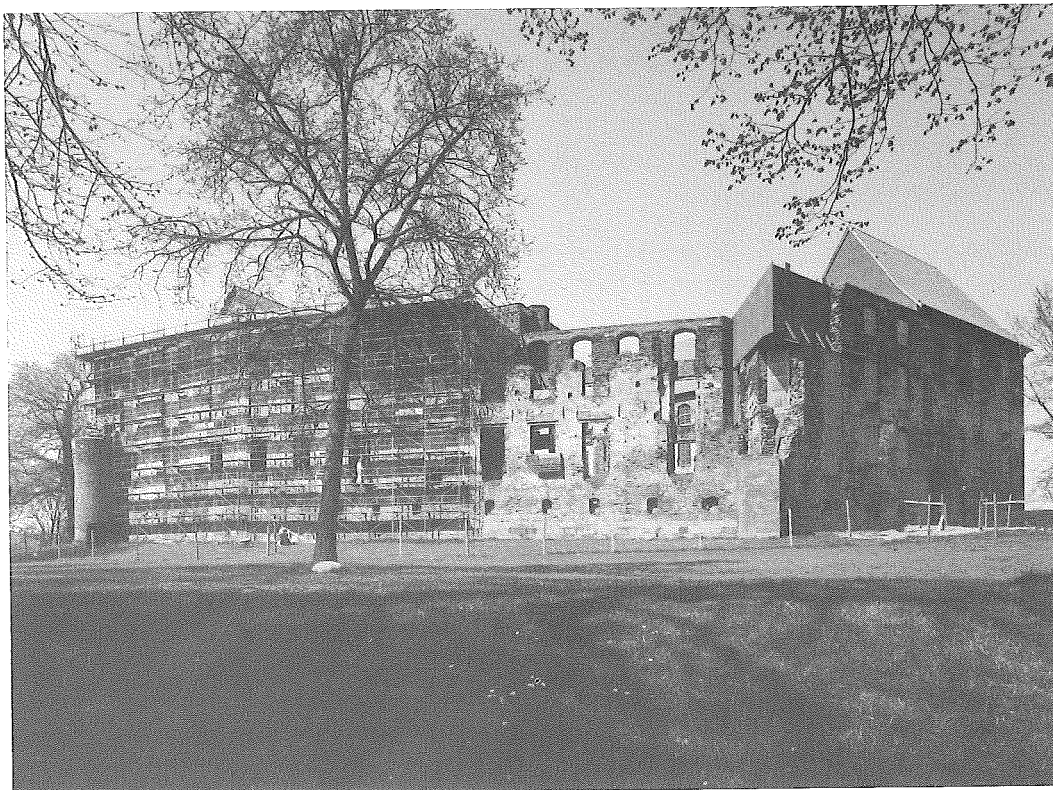
FIG. 8. A view of the castle from the south-east during restoration. The work is being carried out in stages simultaneously from west and east, and the large aperture in the south-east corner has been closed. The roof construction incorporates a horizontal steel truss which connects the east and west wings, simultaneously fixing the load-bearing columns and stabilizing the ruined walls.

In this article we are concentrating on what is being done in the east and south wings where the ruined state is being maintained and presented as a major element in the museum. In selecting the type of supporting structure we were going to insert, we had to consider the fragility of the brickwork and the foundations. If these were to be made load-bearing parts of the structure such extensive reconstruction and consolidation would be necessary that little untouched and original fabric would remain. As already explained, this part of the castle had been built partly on the edge of a moat, and this presented its own problems of stability (*Fig. 8*).

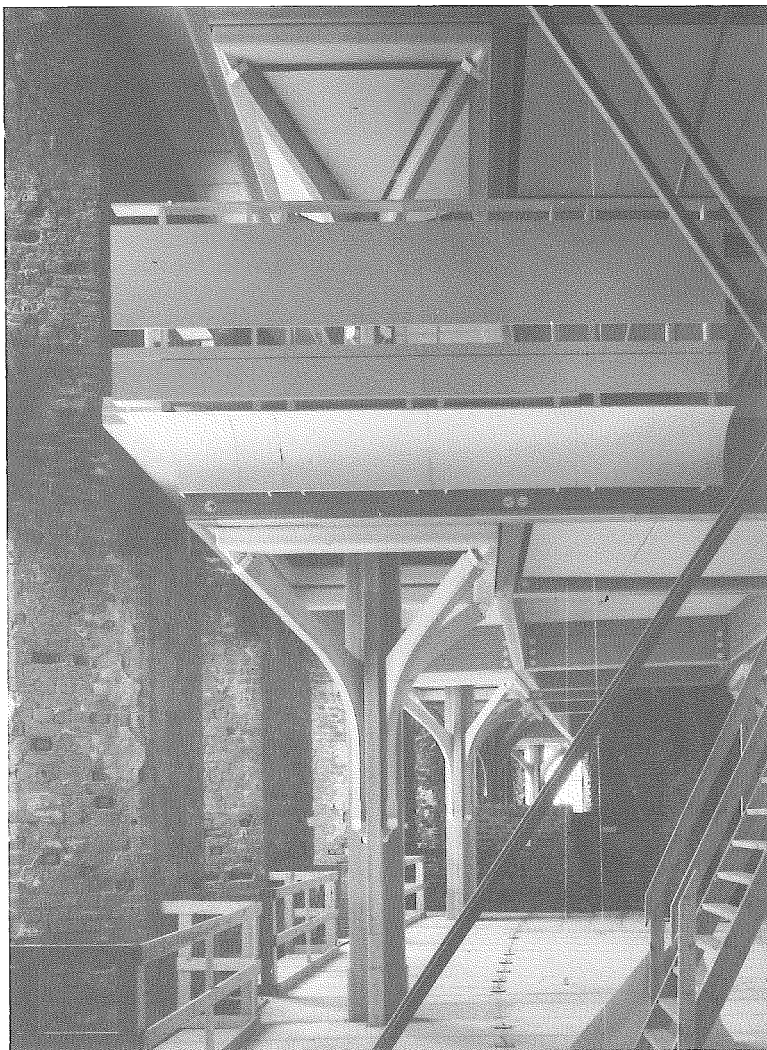
FIG. 11. The interior of the south wing. The new load-bearing structures have been erected; the laminated timber columns with their 'branches' continue through the storey partitions and terminate with a white pyramidal capital. The protective railings, struts and stairs seen here are temporary. (*Photograph: Ernst Kallesoe*)
