offprint: MONUMENTUM, december 1984

# Koldinghus: the conversion of an old royal Danish castle

JOHANNES EXNER\*

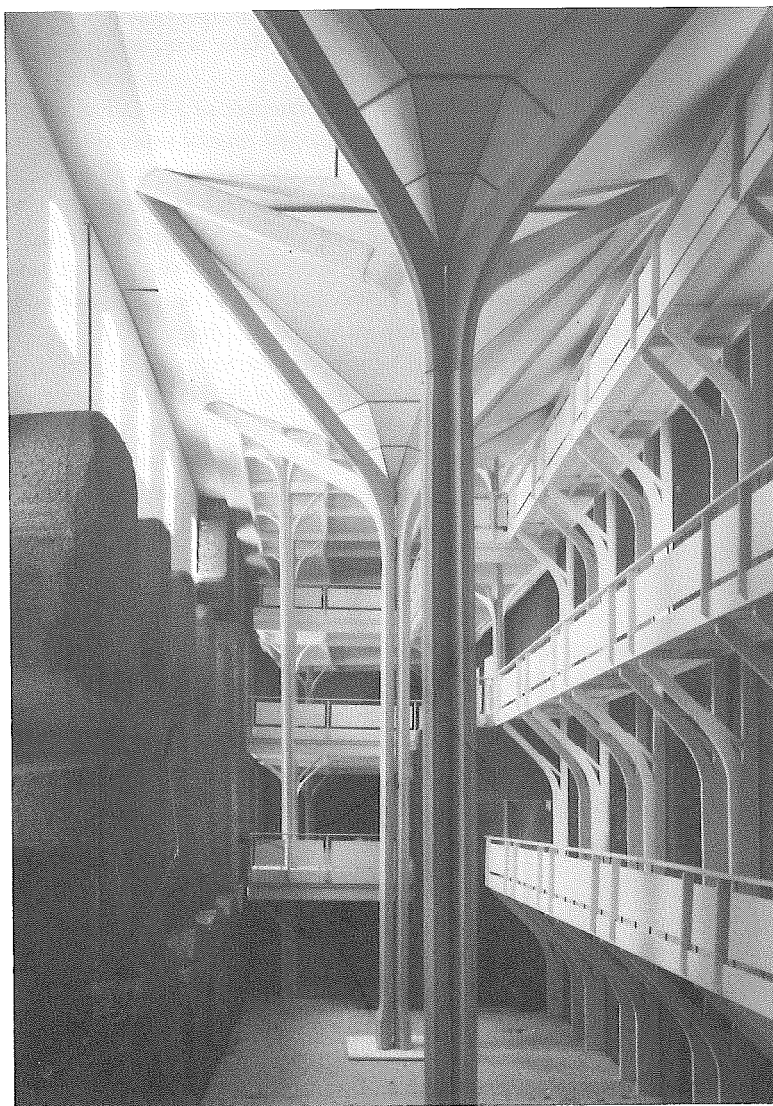
FIG. 1. A model photograph showing the ruined hall in the second proposal which was accepted and is now in progress. The load-bearing constructions are made of laminated timber. The closing of the aperture in the south wall (left) is a curtain-wall of timber, painted white internally and faced externally with oak shingles. (*Photograph: Ernst Kallesøe*)

In order to keep the ruins untouched and to preserve their 'narrative value', a framed structure has been designed to fit within the walls of the ruin (*Fig. 1*). Columns carry the floor decks and roof, and the design also

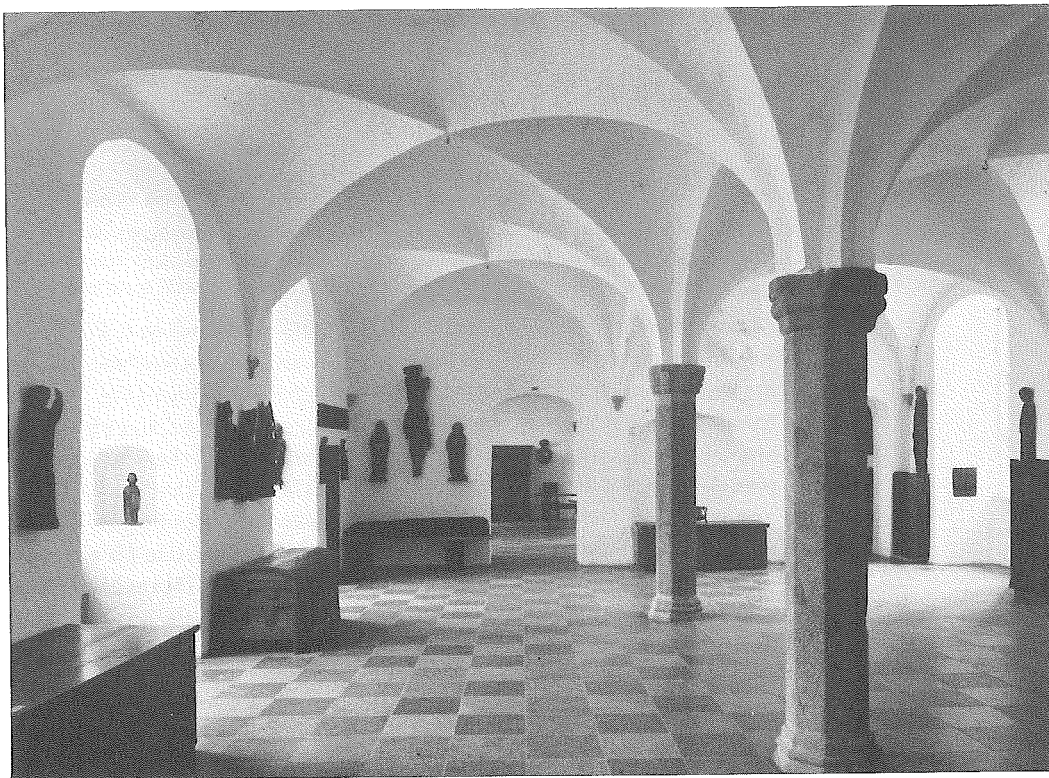
FIG. 2. An exhibition room in the north wing. The vaulted room was reconstructed in 1892 after the discovery of the octagonal granite columns in the town of Kolding. (*Photograph: Ernst Kallese*)

jointing of the fine Gothic masonry are well preserved, and the south gable can be observed by those with a keen eye in the later Christian III's chapel. There are fewer remains to be seen in the north wing, where several alterations and restorations have obliterated the early work (*Fig. 2*). No doubt more profound investigation would add to our knowledge of the Gothic house, but it will have to wait until time and money allow. The work being undertaken at present does not hinder future investigations.

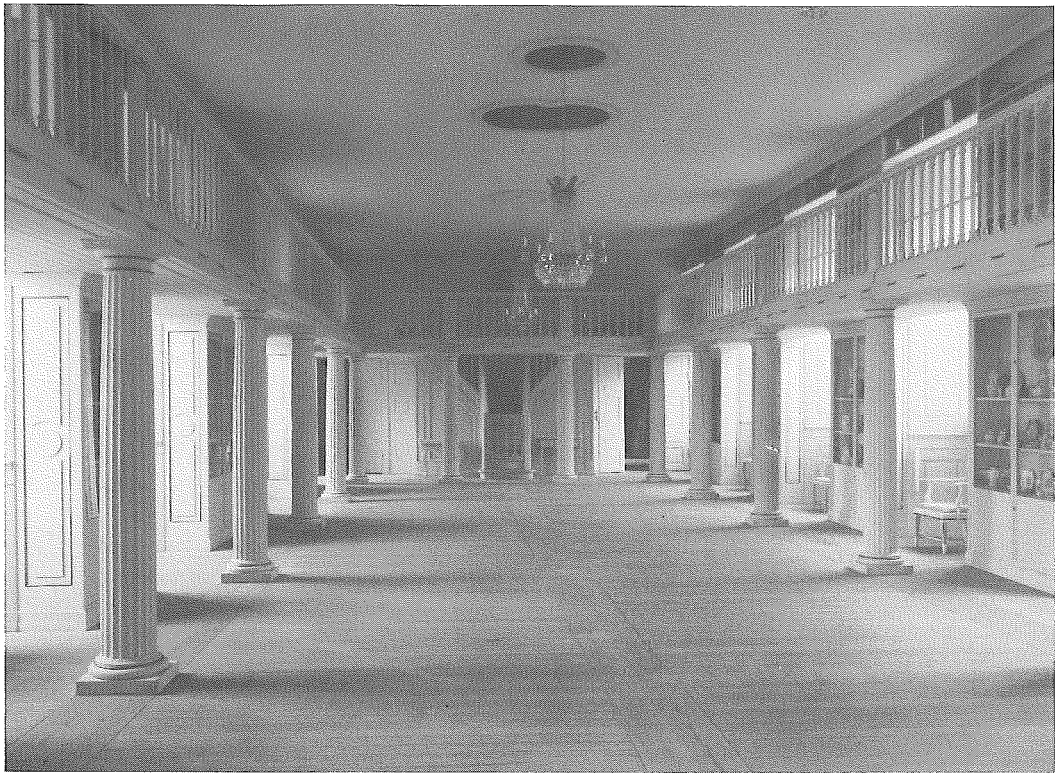
FIG. 5. The fixtures and furniture in the White Hall were originally part of the Royal Library in Copenhagen, designed by H.V. Koch in 1824. It has nothing to do with Koldinghus, but was placed there in 1914 as an exhibit. The fixtures are light and refined, and the room presents a dramatic contrast to the dark ruinous interior of Christian IV's church hall which is immediately next to it. (*Photograph: Ernst Kallesoe*)
